Think It's Dealer Only? **Check Dorman First!** | www.DormanProducts.com

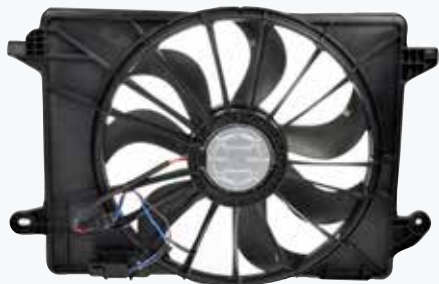
Radiator Fan Assembly

- 10x service life vs. OE and competitor parts
- Ideal for heavy use applications such as law enforcement, fleet, performance vehicles
- Complete assembly including shroud, motor and blade

- Failure signs include illumination of the hot temperature light, engine overheating and fan not operating

Under-engineered motor. Fails prematurely due to high use cooling powerful engine.

Upgraded motor with a proven, brushless motor design (BLDC), 10x the service life vs. the original design!

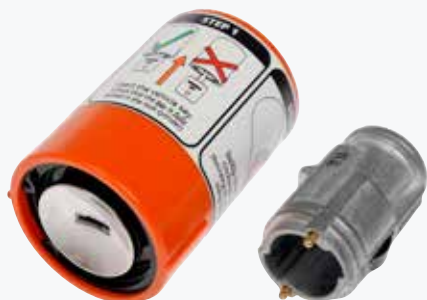
Ignition Lock Cylinder

OE PROBLEM: When the original ignition key fails, the dealer requires an expensive replacement, plus programming.

OE FIX: Calibrates to the original ignition key, eliminating the need to disassemble the cylinder for recoding before use.

- Tumbler wears out over time, resulting in binding and the inability to turn key

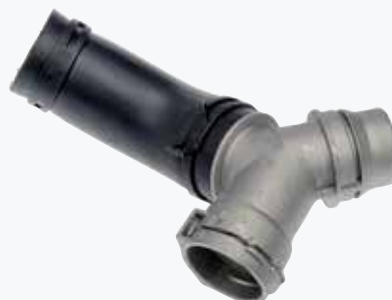
HVAC Heater Hose Assembly

OE PROBLEM: Original heater hose assemblies typically fail due to cracked plastic Y-connectors.

OE FIX: Y-connector material upgraded from plastic to aluminum for increased durability and a longer service life.

- Original plastic Y-connector cracks over time and results in coolant leaks and loss of pressure

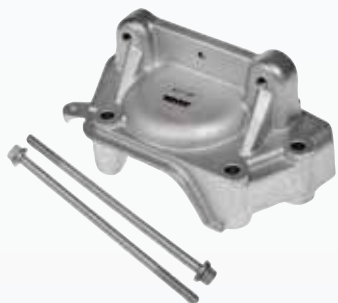
Engine Mount Bracket

Supports engine position in the frame

- Includes required hardware for a complete installation
- Bracket is galvanized for added corrosion resistance
- Easy-to-install, direct-fit replacement

- The engine bracket has to be removed when servicing the timing belt and the hardware seizes to the mount

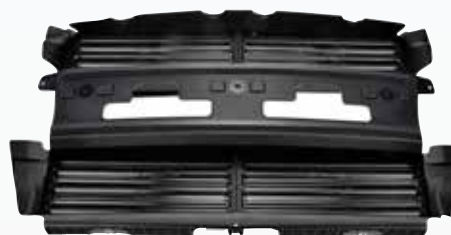
Radiator Shutter Assemblies

- Regulates airflow through radiator to engine compartment
- Comes ready to install with motor for a complete repair
- No programming required

- Broken grille shutters or motor failure results in illumination of the check engine light and higher than normal engine temperatures

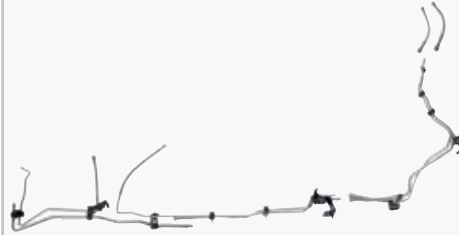
Fuel Lines - Stainless Steel Fuel Line Kit

OE PROBLEM: Original fuel lines rust from exposure to moisture and corrosive road treatments.

OE FIX: Upgraded to stainless steel to resist rust and corrosion. Pre-formed section design solution saves installation time.

FAILURE MODE:
• Rusts from exposure to moisture and corrosive road treatments, which results in fuel leaks and loss of pressure

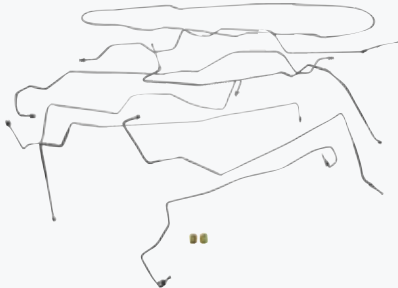
Brake Hydraulic Line Kits

OE PROBLEM: Original steel lines rust from exposure to moisture and corrosive road treatments.

OE FIX: Upgraded stainless steel resists rust and corrosion. Pre-formed section design solution saves installation time.

FAILURE MODE:
• Original steel lines rust from exposure to moisture and corrosive road treatments, which result in fuel leaks and loss of brake power

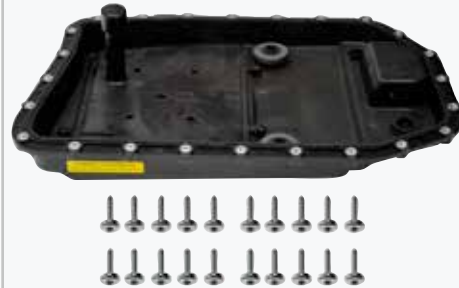
Transmission Pan

OE PROBLEM: When the original filter and gasket fails, the dealer requires replacement of the entire transmission pan.

OE FIX: Available as a complete kit with a removable filter that can be serviced separately, without replacing the entire transmission pan.

FAILURE MODE:
• Impact and collision damage results in oil leaks

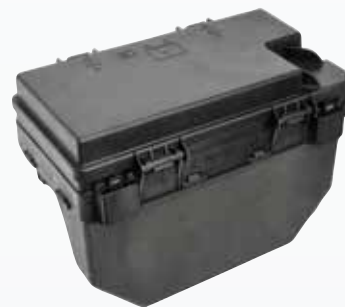
Integrated Control Modules

ALSO KNOWN AS: TOTALLY INTEGRATED POWER MODULE (TIPM)

- Controls a variety of electrical components throughout the vehicle, including windshield wipers, headlamps, radio and so much more
- Fully remanufactured and vehicle simulator-tested for quality assurance
- Updated with the most recent programming available
- Easy-to-install, plug-and-play repair solution; no special tools or programming required

FAILURE MODE:
• Internal circuit failure causes erratic electrical problems in original unit
